PROJECT APPLICATION FORM – 2010

Applicant: Acton Community Center, Inc. (dba Theatre III) Submission Date: November 15, 2010 Applicant's Address, Phone Number and Email Purpose: (Please select all that apply) Physical Address: 250 Central St., Acton, MA O Open Space 01720 Mailing Address: 19 Capt. Brown's Lane, O Community Housing Acton, MA 01720 Contact for Grant Application: XO Historic Preservation Pamela Furnace 233 Old Beaverbrook Rd. Acton, MA 01718 978-263-5711 Recreation Town Committee (if applicable): Community Preservation Committee Project Name: Restoration of Exterior Building Envelope

Based on recommendations of a historic preservation survey conducted by Gorman, Richardson, Lewis Architect in 2010, this project represents Phase 1 of restoration of this historic building. The primary need is immediate restoration and rehabilitation of the exterior envelope of the building. This work will include

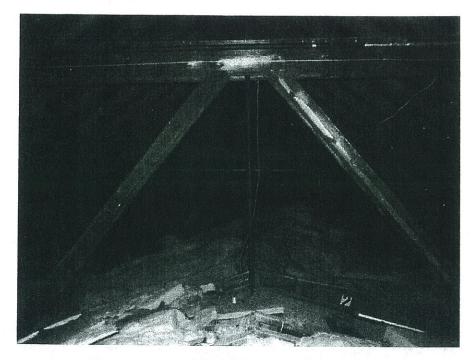
EXISTING TRUSSES OVER THEATER

Two different roof framing conditions exist in the building. Over the stage, the roof is conventionally framed with wood rafters and 2x6 ceiling ties at the base of each rafter. Framing over the theater consists of wood rafters supported on wood timbers that run in the longitudinal direction. The wood timbers are supported on three timber trusses that span the width of the building. The bottom chords of the trusses are sloped to match the cathedral ceiling inside the theater. The top chords of the trusses are truncated at approximately 5' above the high point of the bottom chord. Additionally, there are two steel tie rods that extend through the theater space at the height of the top of the exterior walls. The tie rods extend through the exterior walls and are anchored on the outside of the building with nuts and steel plate washers.

- The top chord of the timber trusses has deflected several inches, likely caused by creep from long term stresses.
- The tops of the exterior walls on the north and south side of the building have bowed several inches outward.
- The steel plate tie rod anchors have crushed the clapboard siding due to excessive forces applied at the anchor plates

Since the bottom chords of the trusses are sloped, the deflection in the top chords of the trusses translates into horizontal movement at the truss bases. The horizontal movement has caused the bowing at the tops of exterior walls. It appears that the tie rods were installed later as an attempt to stop further bowing of the walls; however, the anchorage points may not have been adequately constructed to resist the applied forces.

One possible solution is to reinforce the top chord of the trusses with steel plates or channel sections. This will stabilize the top chords of the trusses and prevent further deflection. Additional tie rods can be installed that are properly anchored to the tops of exterior walls. It should be noted that we would not recommend attempting to bring the exterior walls back into proper alignment, as this may induce large stresses on the structure and potentially cause problems with roofing, finishes, windows, and other building components.

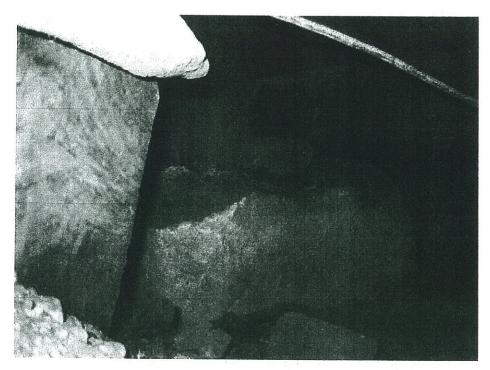
The existing floor framing is 2'-3' higher than the dirt floor of the crawl space. Due to the height of the crawl space, construction of the elevator pit would not require a deep excavation that would significantly impact existing foundations. There is one 8x8 wood post in the area of the proposed elevator; however, it could be relocated as part of the reframing around the elevator shaft.

POST IN VICINITY OF PROPOSED ELEVATOR

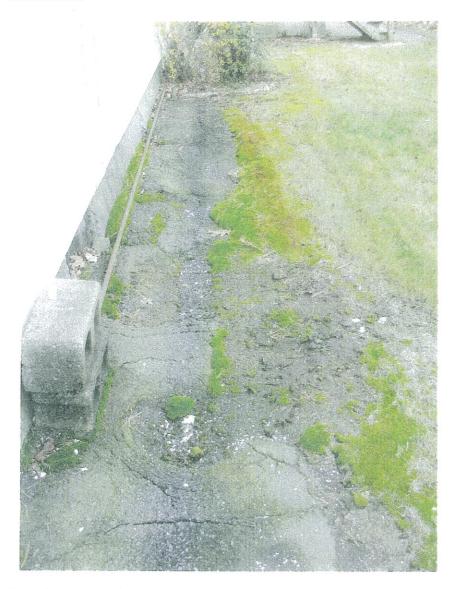
- Water and animals have intruded through the foundation walls into the crawl space. (Photos 1-1 through 1-4) The foundations will be sealed and properly vented. Asphalt along the north façade will be removed and drainage for water from the roof will be inserted. A retaining wall and drainage will be built up along the south façade where the foundation is currently filled with loose rocks and rubble.

1-1 North Façade. Notice the asphalt which has been laid to prevent water damage from watter draining off the roof. Asphalt needs to be removed and proper drainage installed.

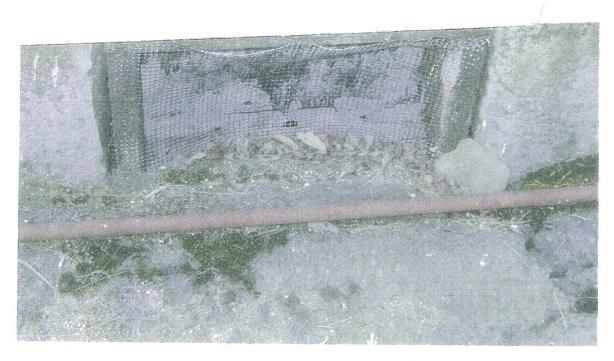
1-2 North façade opening.

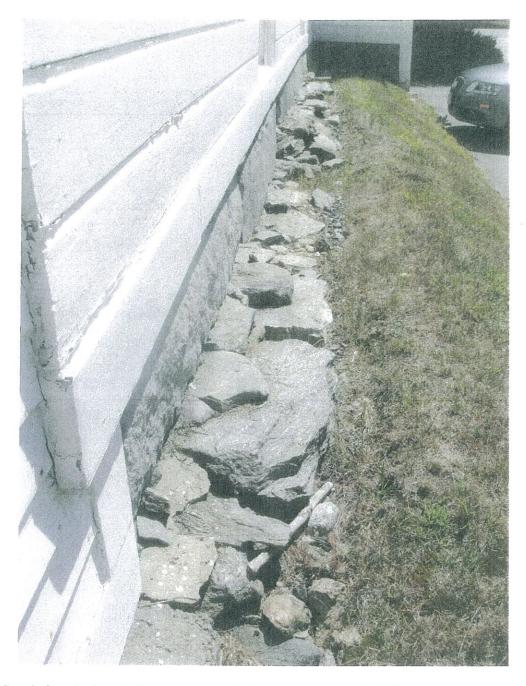
1-3 South façade foundation showing rubble below grade. Rubble has been randomly filled in over the years. Water drainage from roof erodes dirt beneath rubble over time and subsequently drains into crawl space under building. Plans call for adding draining, filling gaps along foundation and building a retaining wall to direct water away from building.

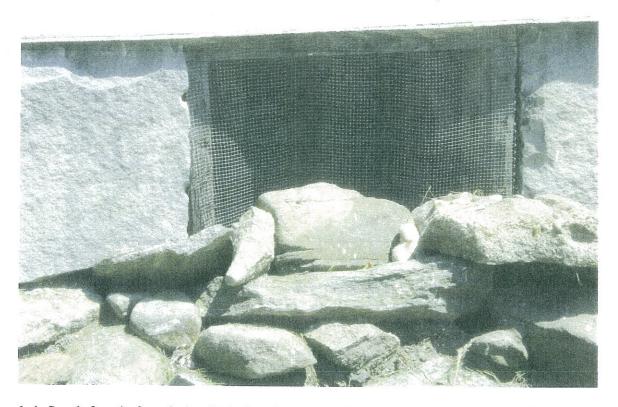
1-4 South façade foundation "window." Note the holes between rocks and broken screen, allowing for animal intrusion as well as water.

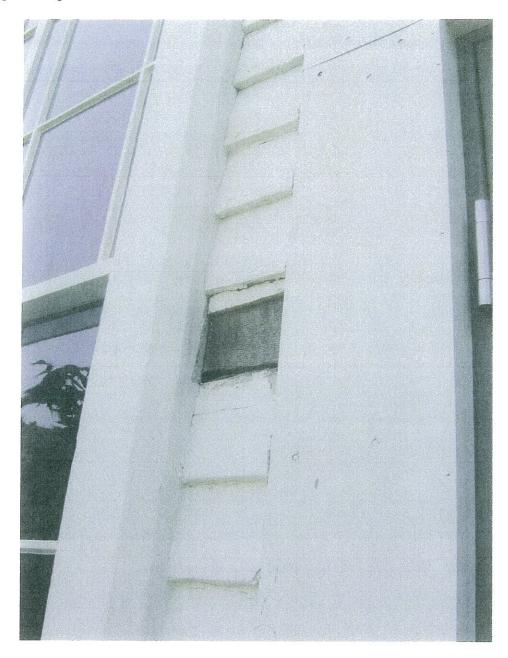
- Many areas of clapboards are rotted and damaged from water and insects.
 (Photos 2-1 through 2-4) Damaged clapboards will be replaced and sealed.
- Temporary repairs done in the fall of 2009 to provide immediate relief from water intrusion will be replaced with the correct wood trim, milled to match existing details. (Photos 3-1 and 3-2)

2-1 Damaged clapboard, north façade between window and fire escape door.

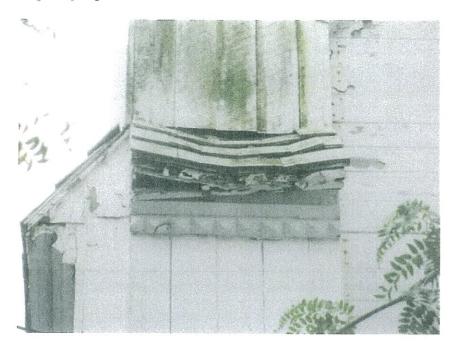
3-1 Damage to front façade before repairs.

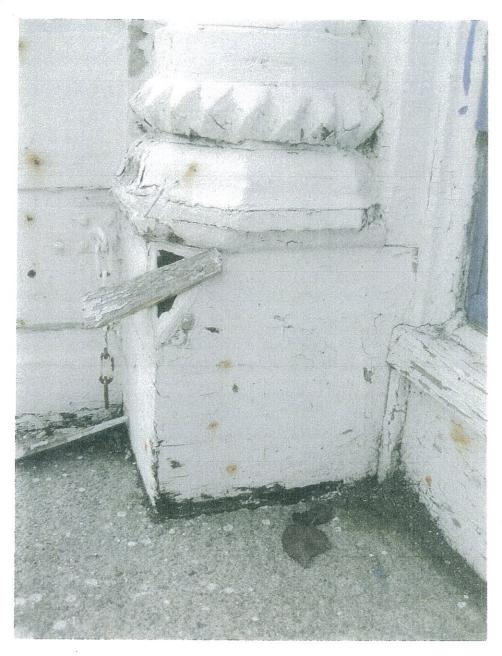
4-1 Front façade decorative column, denoting extensive damage.

- Sections of architectural decorative woodwork are rotten or broken. (See Photos 4-1 through 4-3). These pieces will be recreated and repaired to match existing detail.

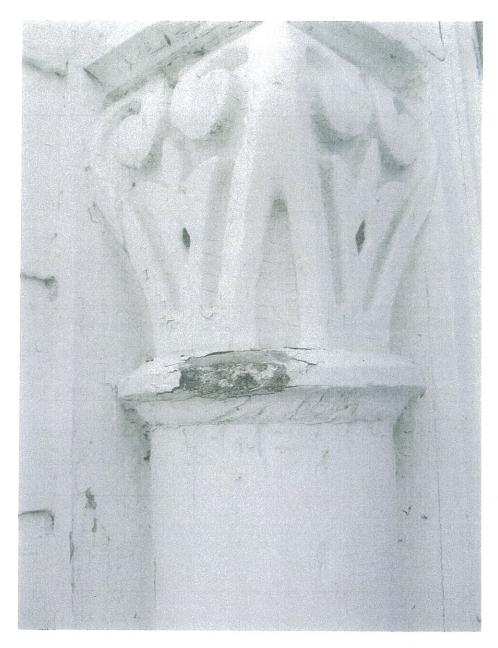
4-2 Front façade decorative column, denoting damage.

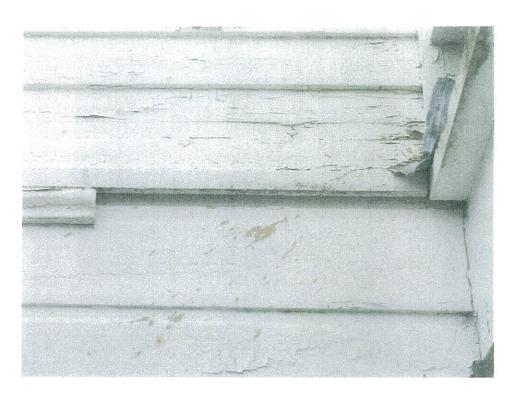
4-3 Missing trim, north façade.

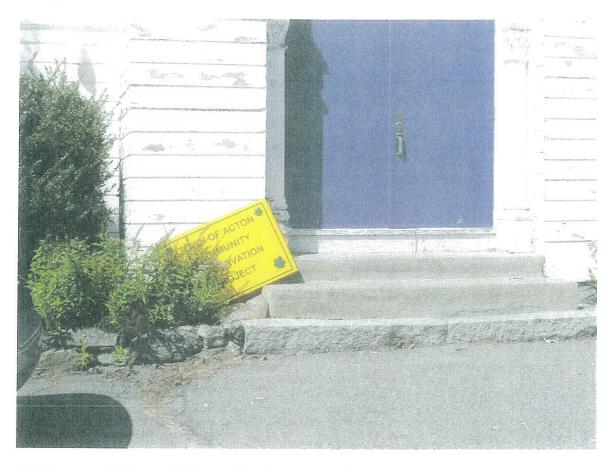
5-1 Front steel doors. All 6 exterior doors are similar and all will be replaced.

- The current steel doors are not historic and are rusting (Photo 5-1). The doors will be replaced with historically appropriate wooden doors that meet safety standards and which provide necessary insulation.

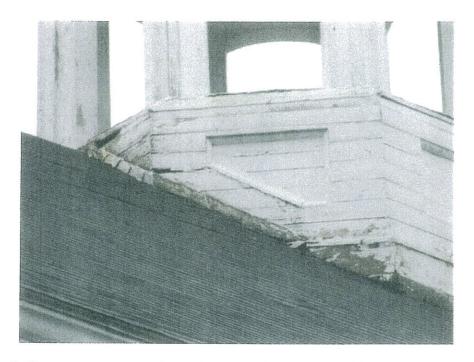
6-2 Steeple from south façade. Note damaged side walls and flashing.

- The base of the steeple is rotting and full of holes and the roof of the steeple has many broken shingles. Flashing around the steeple is leaking, causing water damage on the interior (Photos 6-1 through 6-3). All rotted wood will be replaced, flashing will be replaced and the steeple-to-roof junction will be made watertight.

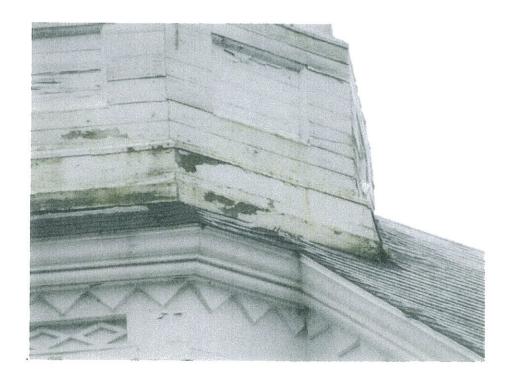
6-3 Steeple from front. Note damage at base, broken roof tiles and missing flashing.

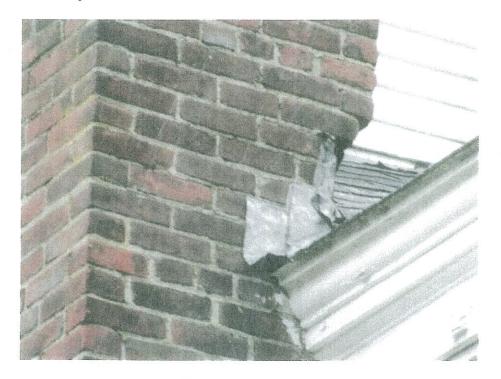
7-1 Chimney showing missing bricks and damaged flashing.

- There are some shingles on the main roof which are broken as well. Broken shingles will be replaced and flashing repaired as needed.
- The brick chimney is non-functional and is in danger of collapse. (Photos 7-1 and 7-2) The chimney will be removed to the roof level of the attached mechanical room and clap boards will be inserted to fill in the space

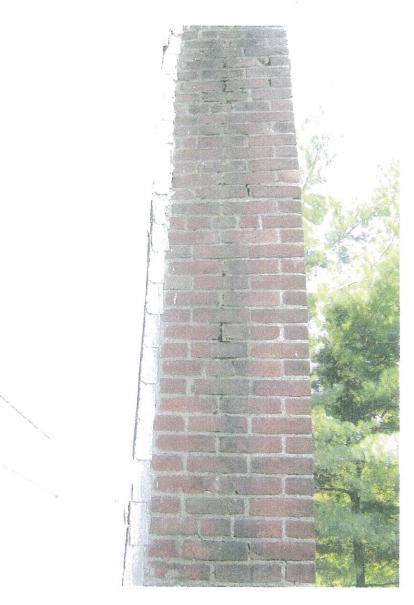
7-2 Chimney with broken bricks and damaged flashing.
